ATSB TRANSPORT SAFETY REPORT
Aviation Occurrence Investigation
AO-2008-070
Final

In-flight upset
154 km west of Learmonth, WA
7 October 2008
VH-QPA
Airbus A330-303

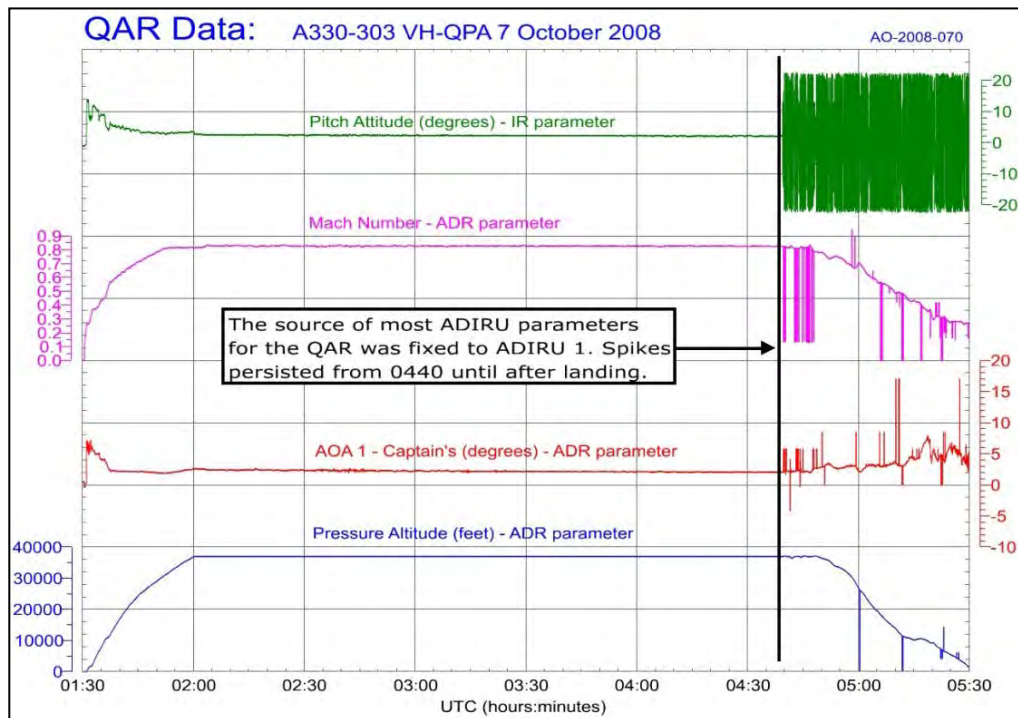
Figure 21: QAR plot showing key ADIRU parameters

The QAR data showed that the flight was uneventful until 0440:26 when spikes became evident on all of the recorded ADR and IR parameters from ADIRU 1. The data spikes continued until the aircraft landed. The QAR data for several key ADIRU parameters are shown in Figure 21. As indicated, frequent spikes were recorded in IR parameters, and intermittent spikes were recorded for ADR parameters.

When there were no spikes, the ADR parameters appeared to be correct. In addition to the data spikes, all of the IR parameters showed persistent deviations from their expected values. For most of these parameters, the deviations showed oscillatory behaviour (Figure 22). The groundspeed parameter showed a different characteristic, gradually diverging from the actual value and increasing to 1,000 kts, where the value remained for the rest of the flight, except for a number of lower-value data spikes.

- The presence of spikes for all ADR parameters on both the FDR and QAR throughout the flight after 0440:26, indicating that ADIRU 1 flagged most of its ADR output data (including the data spikes) as valid.
- The presence of spikes for all IR parameters on the QAR but not the FDR during the period from 0440:26 to 0443:45 (when the ATT HDG switch position was changed), indicating that ADIRU 1 flagged most of its IR output data as invalid.

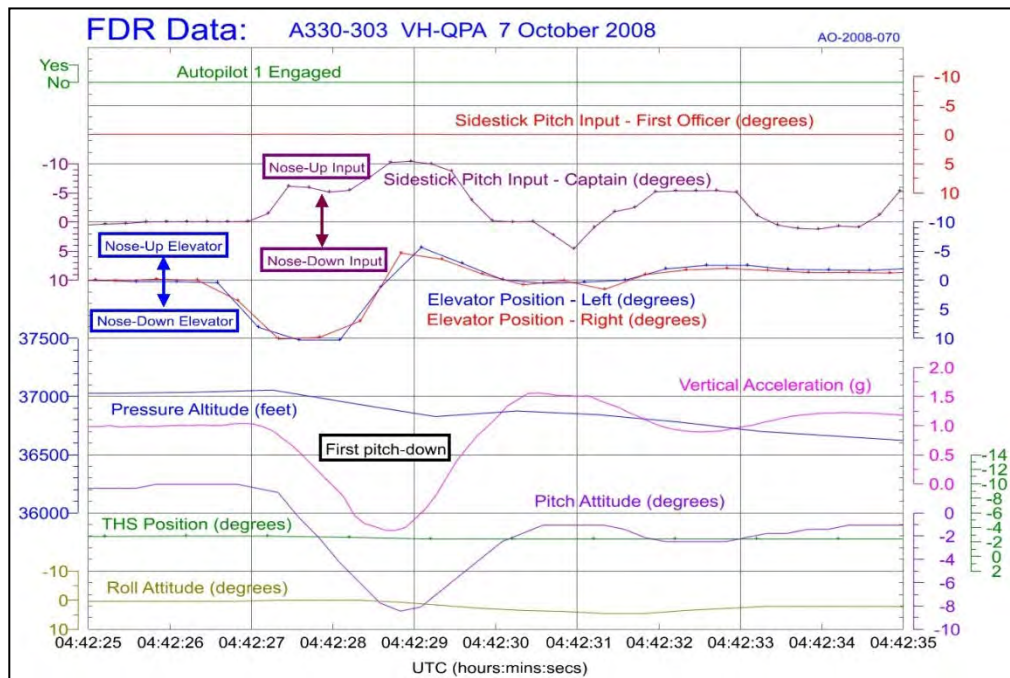
Figure 24: Acceleration, elevator and sidestick inputs for the first pitch-down

During both pitch-downs, both elevators' positions changed abruptly in the nose-down direction (Figure 24 and Figure 25). The magnitude of the change for the first pitch-down was larger, and the rate of change was approximately 15° per second. The duration of the second pitch-down was slightly longer than the first. The abrupt changes for both pitch-downs were followed soon after by a slower recovery period back to normal values.

The movements of the left and right elevators were consistent, and the magnitude of the elevator movements was also consistent with the magnitude of the aircraft's pitch changes.

There was no sidestick input that correlated with the initiation of either pitch-down. In both cases, very soon after the pitch-down commenced, the captain applied back pressure to the sidestick to produce a nose-up input. Each was moderate and commensurate with the response required to correct for the pitch-downs. The inputs did not have any immediate effect on the recorded elevator position, but within 1 to 2 seconds the elevator position started to correlate with the sidestick inputs. Figure 24 and Figure 25 show the sidestick pitch input parameters for the 10-second period around each pitch-down.

Figure 24 shows the vertical acceleration during the first pitch-down, and Figure 25 shows the vertical acceleration during the second pitch-down. There was no evidence of any turbulence in the recorded data during these periods.

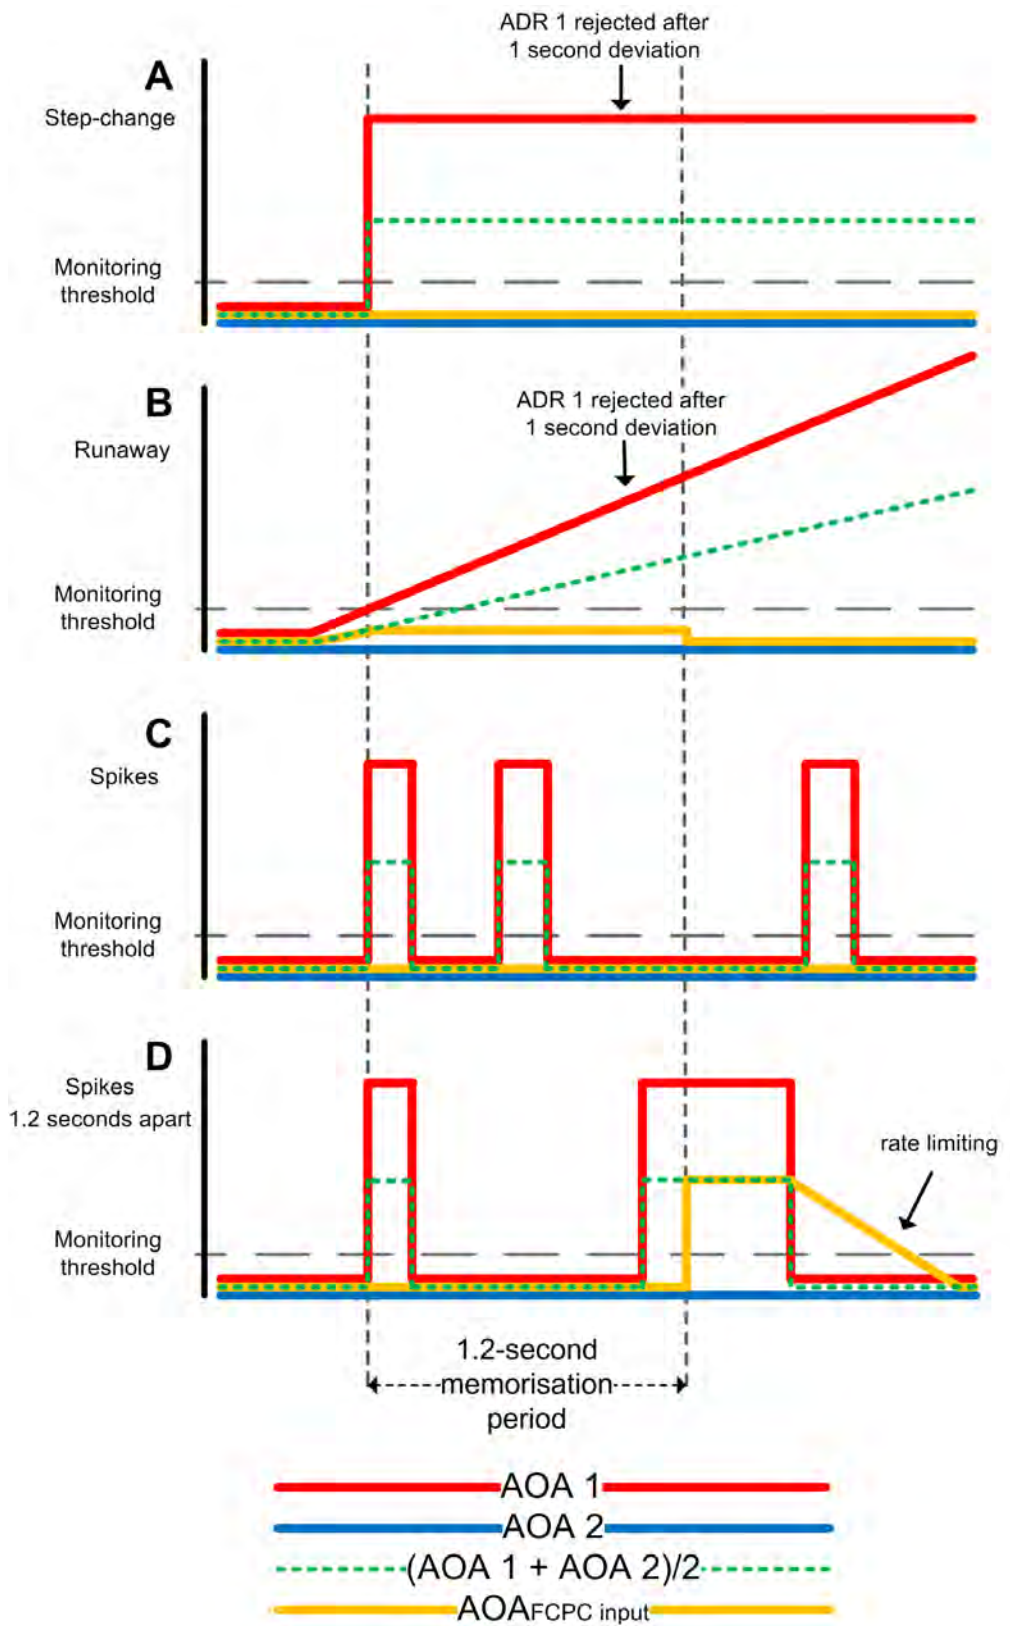
Figure 29: FCPC processing of several AOA input scenarios

- The first spike was different to the median of the three AOA values, triggering a 1.2-second memorisation period. This spike lasted for less than 1 second.
- The second spike was present at the end of the memorisation period (1.2 seconds after the start of the first spike).

If this scenario occurred, the FCPC would treat the second AOA spike as valid data after the end of the memorisation period.

Scenario D in Figure 29 illustrates an example of this scenario involving incorrect inputs from AOA 1. AOA 2 remains at the actual value, while AOA 1 has two large-value spikes with the second present 1.2 seconds after the start of the first . The calculation of $AOA_{FCPC\ input}$ is as follows:

The aircraft manufacturer had identified this scenario when it developed the A330/A340 aircraft. However, a simultaneous failure of two ADRs (or related components) was considered to be ‘extremely improbable’ (section 2.5.3).⁸⁰

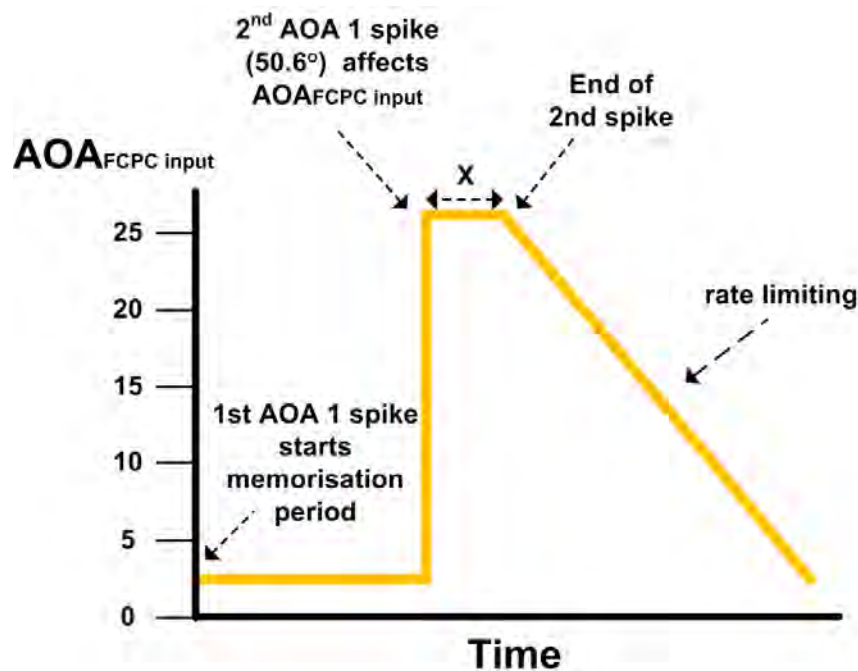
Figure 30: AOA values used in the simulation study for first pitch-down⁸⁴

The time period that the second spike existed after the end of the memorisation period was then varied. This time period is represented by the value of 'X' in Figure 30.

This study confirmed that the recorded elevator deflections during the first pitch-down could be produced using a 26° value of $AOA_{FCPC\ input}$ for a duration of about 400 msec at the end of the memorisation period (that is, the value of X was 400 msec). Based on this simulation, it could be concluded that the AOA 1 spike of 50.6° lasted at least 400 msec but less than 1 second.⁸⁵

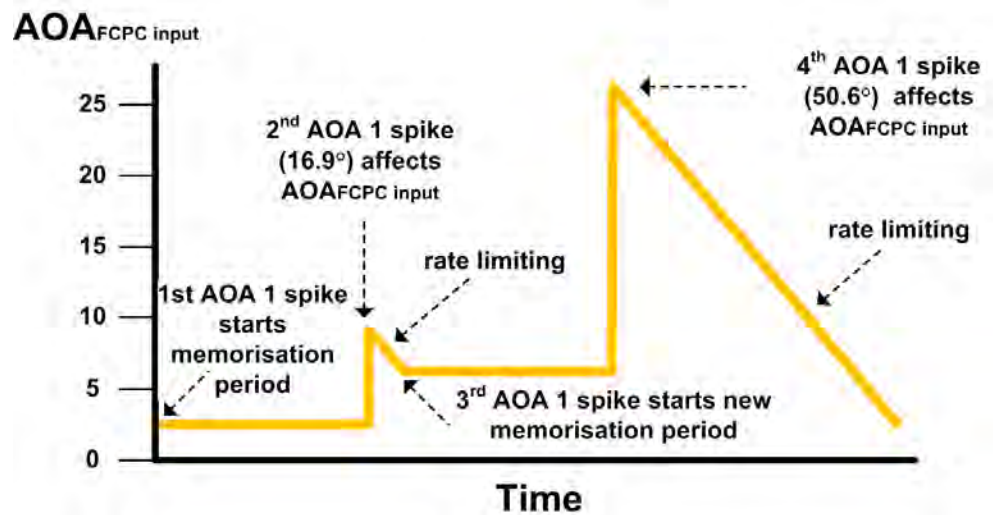
Figure 31: AOA values used in simulation study for second pitch-down

The same process was used to determine the AOA values required to replicate the second pitch-down (at 0445:08). A single memorisation period with different spike values and durations did not match the recorded elevator movements. Further studies identified a more complex scenario that did match these movements, and this scenario involved at least four spikes in succession and triggering two memorisation periods in $AOA_{FCPC\ input}$, as shown in Figure 31.⁸⁶

The aircraft manufacturer also advised that the matching scenario required that the control law reverted to alternate law at about the time of the fourth spike. Consequently the high AOA protection was not available after this time, and there was only 6° of elevator deflection from the anti pitch-up compensation. This figure matched the maximum nose-down elevator position of 5.4° that was recorded during the second pitch-down.

Based on this scenario, the flight crew’s sidestick inputs would have had no influence on the aircraft’s pitch for about 2.8 seconds during the second pitch-down.

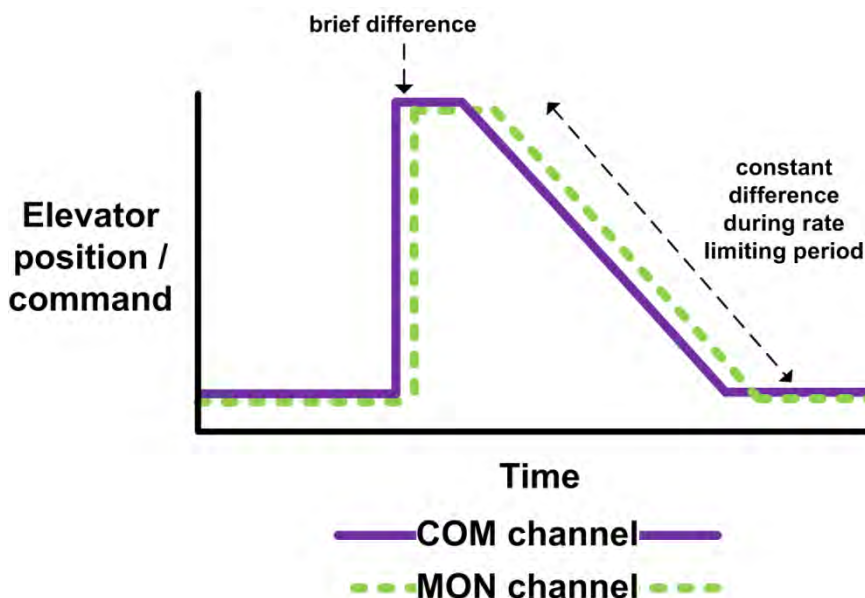
Figure 32: Simplified representation of the COM and MON differences during the pitch-downs

Following the F/CTL PRIM 1 PITCH FAULT message, FCPC 1 could no longer act as the servo-controller for the elevators, or as the master FCPC in normal law. Based on the system design, another FCPC (in this case FCPC 3) became the master, and FCPC 2 took over as the servo-controller for the elevators.

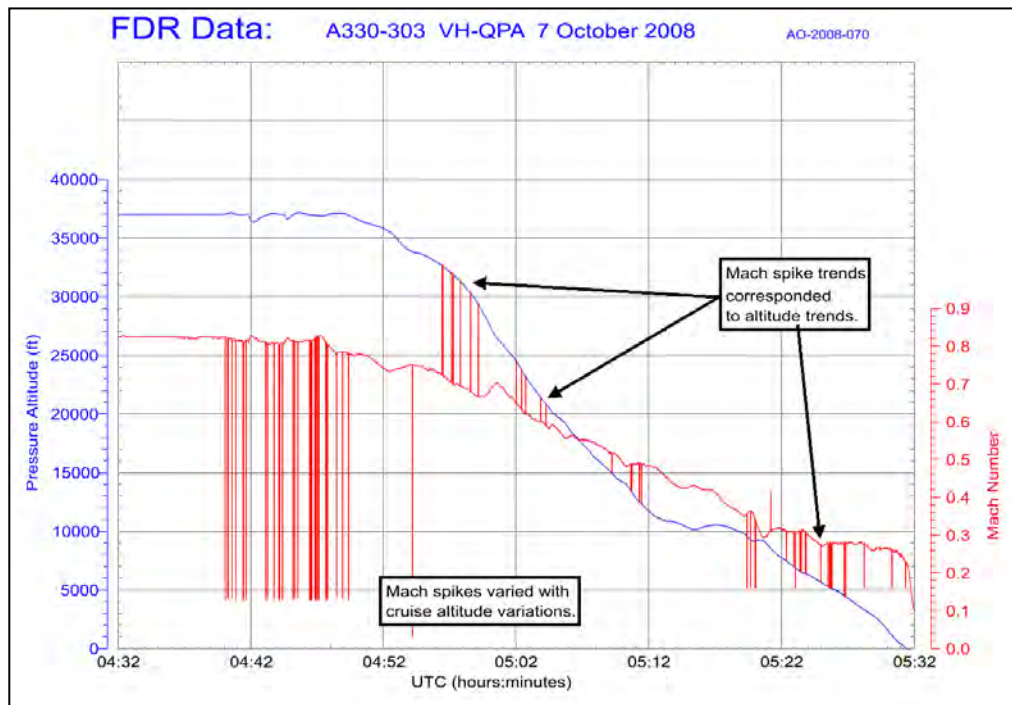
Figure 41: Qualitative correlation between Mach spikes and altitude

A review of the data-spike values for Mach indicated that many of them appeared to vary with altitude. A more detailed examination identified the following relationship (see also Figure 41 and Figure 42):

- While the aircraft was at 37,000 ft, the value of most of the Mach spikes was 0.128. The Mach binary values corresponded to the altitude binary values for 37,000 ft (see also Figure 39).¹³¹
- During the aircraft's descent to Learmonth, the binary values for most of the Mach spikes corresponded to the altitude value at the same time.
- Overall, 88% of the ARINC 429 binary values for the Mach spikes matched exactly with the corresponding altitude values at the corresponding time.

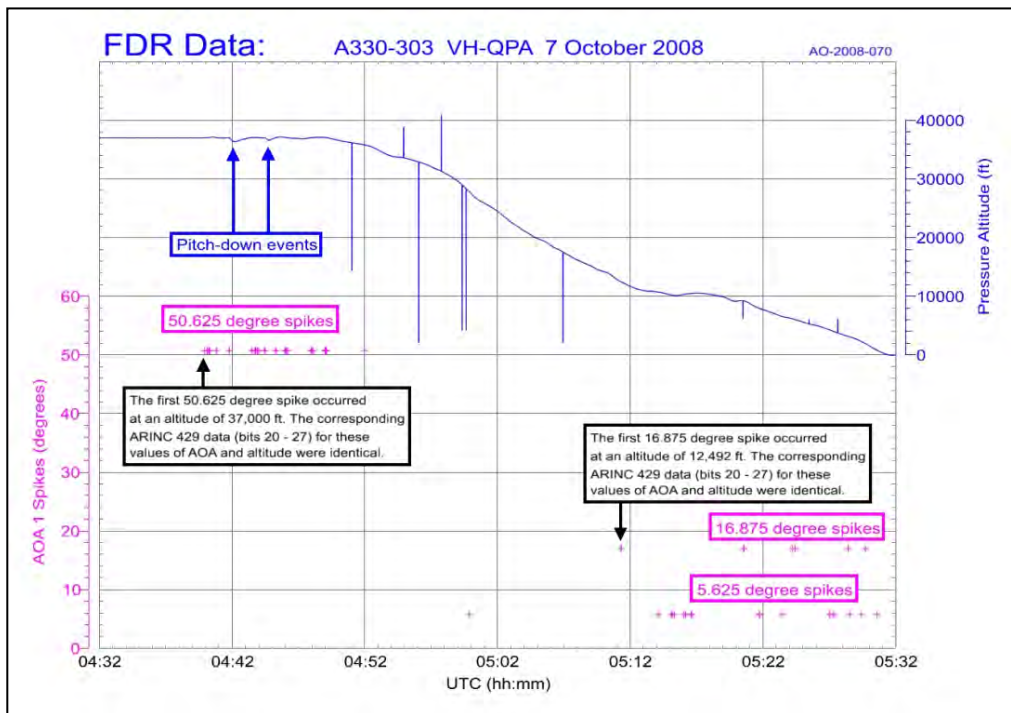
Figure 43: Qualitative correlation between AOA 1 spike values and altitude

There was also some evidence of matching between the corrected AOA data spikes and the altitude values. This evidence included the following (see also Figure 43 and Figure 44):

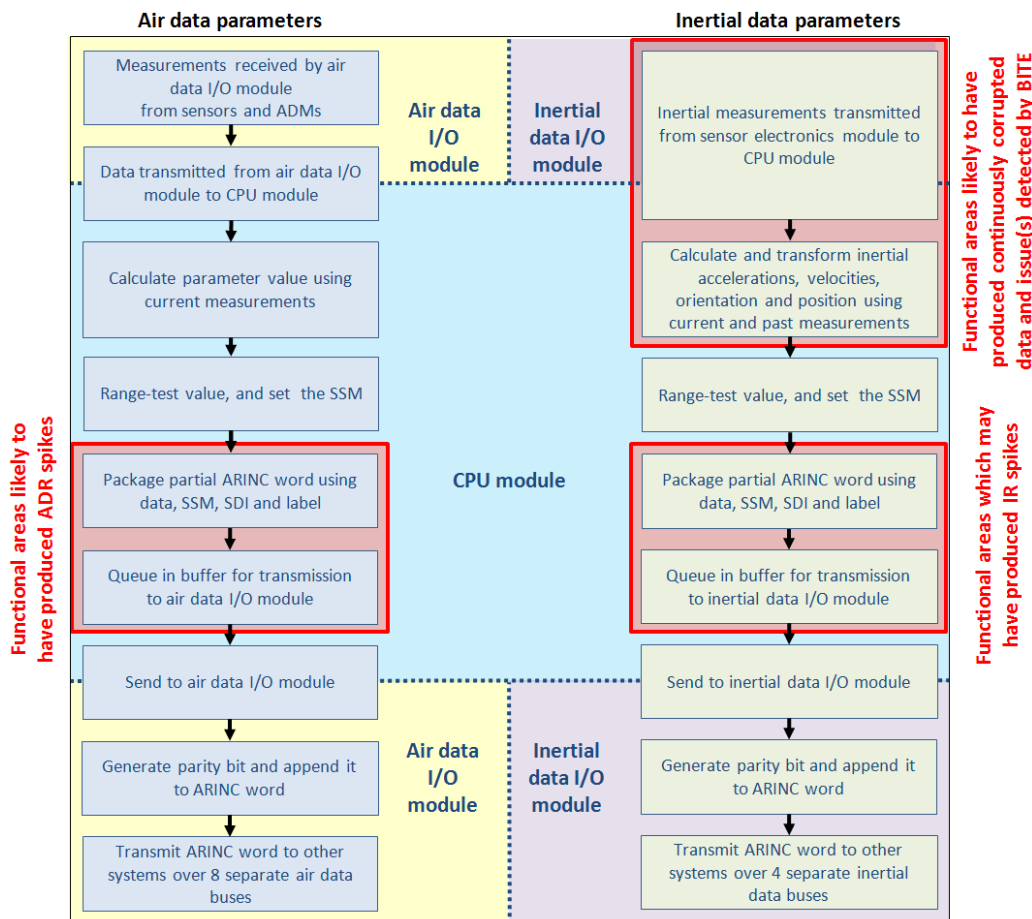
Figure 45: Summary of the data flow for the ADR and IR parameters

parameters is provided in Figure 45.¹³² The processing stages considered likely to be affected by the data-spike failure mode are highlighted in red in Figure 45 and discussed in the remainder of this section.

Based on the various analyses, the investigation was able to limit the possible functional areas that could have produced the observed output data patterns (as summarised in Figure 45). More specifically:

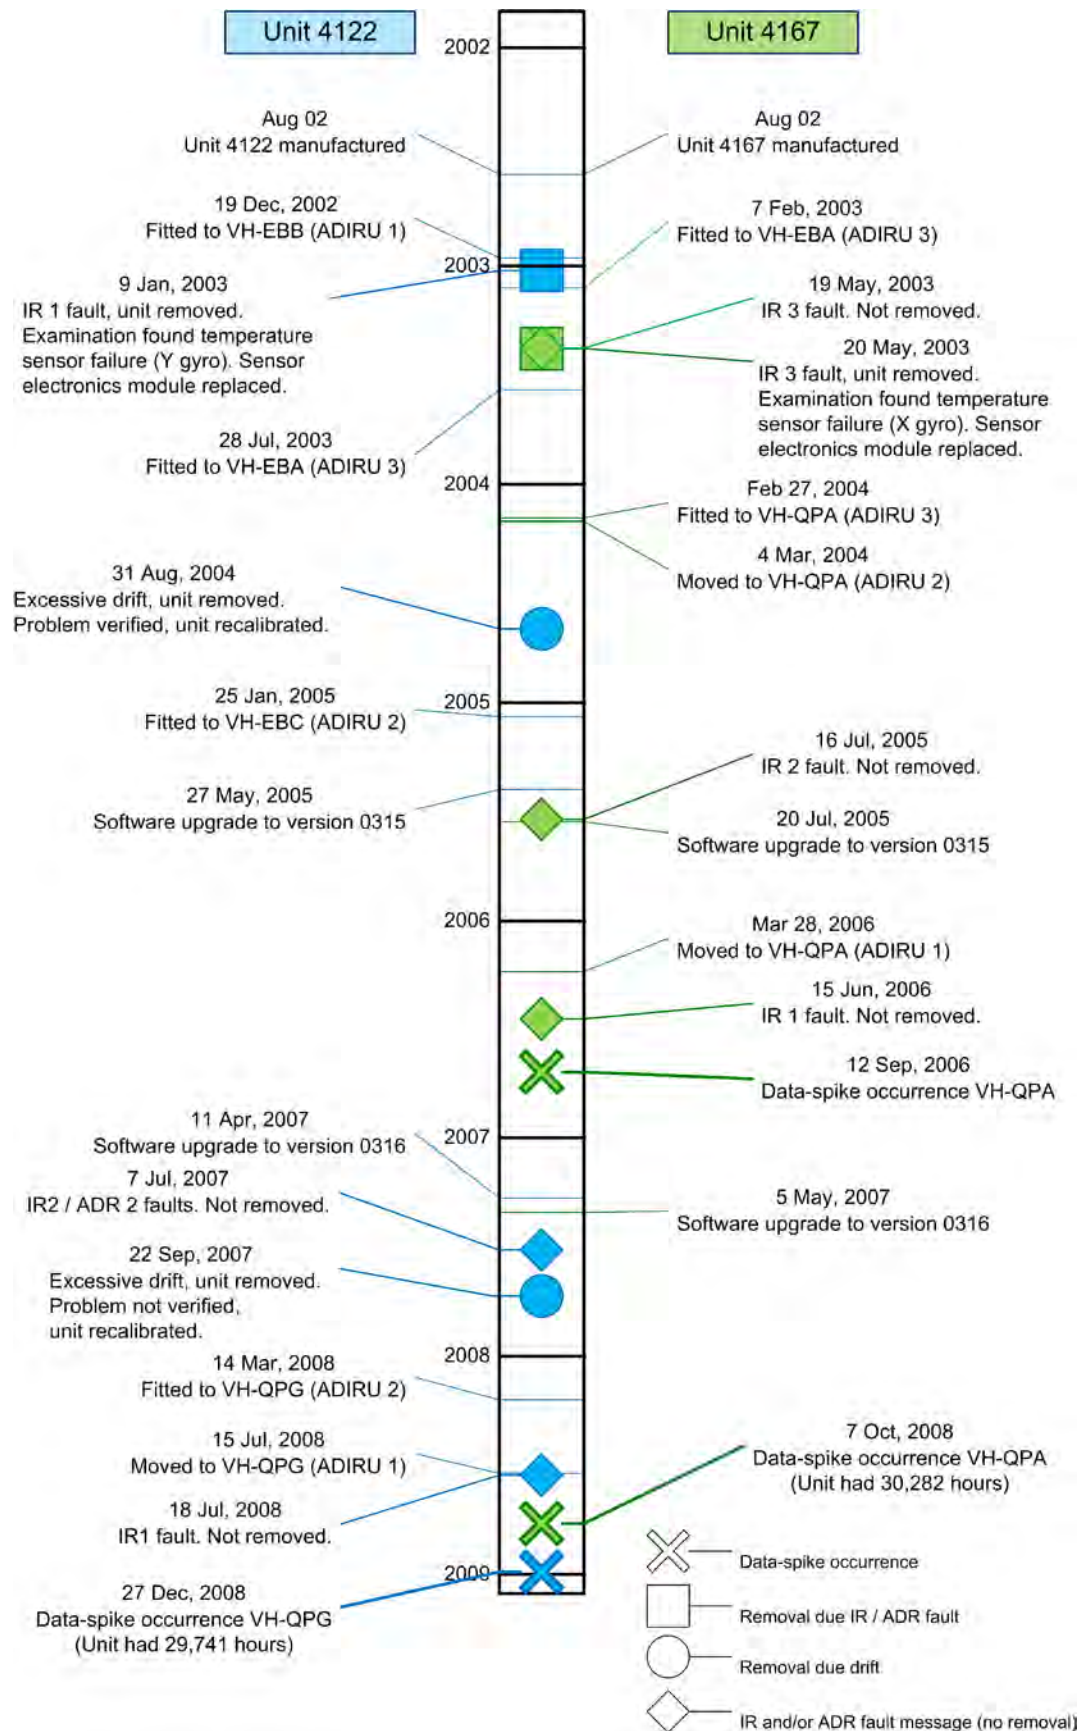
Figure 46: Service history timeline for units 4122 and 4167

Details of the service histories of units 4167 and 4122 are summarised in Figure 46. Notable features include:

The key hardware components in the CPU modules of units 4167 and 4122 were very similar, but the number of other units that had the same level of similarity could not be determined as component details were not recorded.

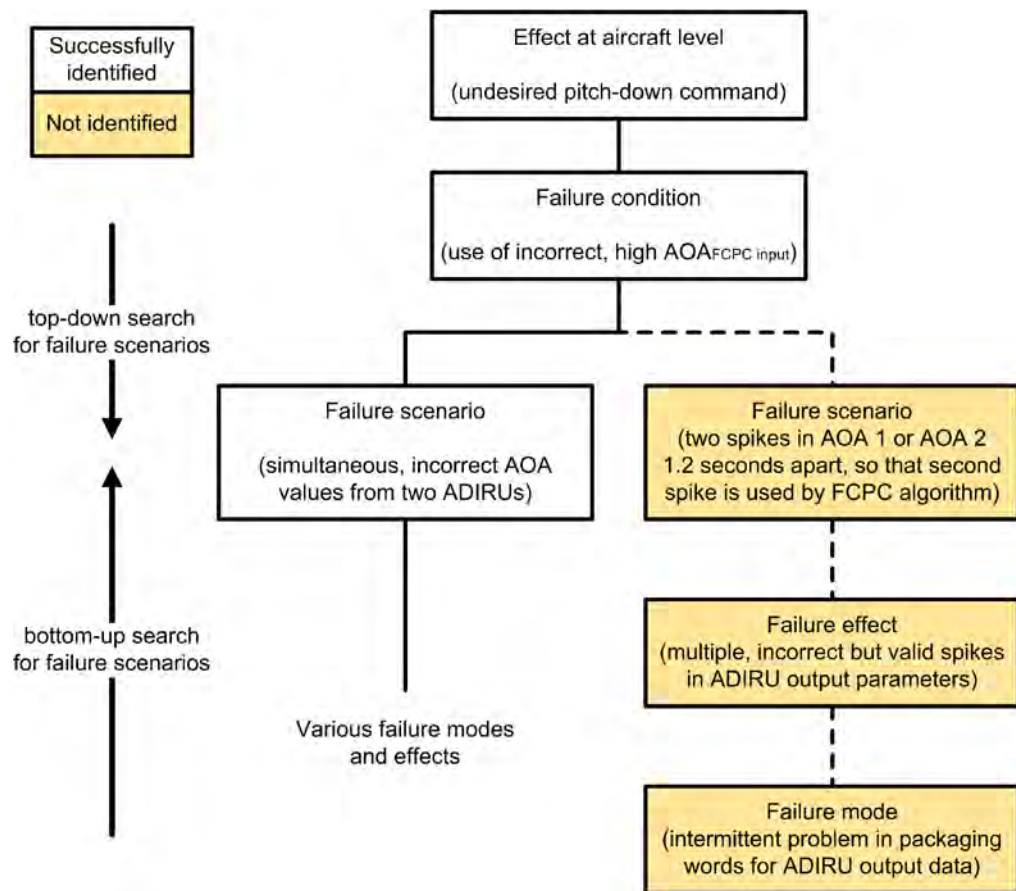
Figure 54: Summary of results of SSA activities for FCPC algorithm

²⁰⁰ The second pitch-down consisted of two commands very close together in time, and was considered to be a single event for the purposes of this type of assessment.

There were alternative algorithm designs or additional features that, in hindsight, would have prevented the design limitation or reduced its influence. Examples include rate limiting on the three AOA input values, range checks on the input values, or reasonableness checks involving comparisons between pitch and AOA. However, a system development process needs to balance many competing requirements, such as minimising the risk of introducing new failure conditions and design errors, minimising the data processing resources required, and unnecessary complexity. The inclusion of specific design features must be based on an identified need, and in this case the system development process did not identify the design limitation and therefore the need for any additional features.

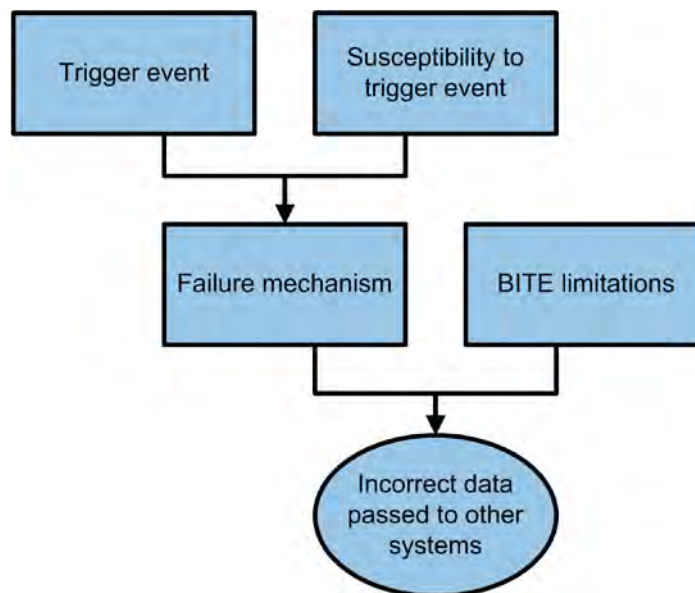
Figure 55: Simplified model of the ADIRU data-spike failure mode

The most significant aspect of the failure mode associated with the pitch-downs was that the ADR data spikes (particularly for AOA) were sent to the FCPCs and other systems as valid data. The elements involved in producing these data spikes are summarised in Figure 55. In simple terms, a trigger event combined with a susceptibility within the ADIRU to that type of trigger event to initiate a failure mechanism that disrupted the ADIRU's internal processing and generated the data spikes. A limitation in the coverage of the ADIRU's built-in test equipment (BITE) meant that the ADR data spikes were transmitted to other systems as valid data.

A series of analyses determined that the failure mode almost certainly occurred with the ADIRU's central processing unit (CPU) module. More specifically, evidence indicated that many of the data spikes for ADR parameters were produced when the CPU module packaged the 32-bit output data words. These data spikes were found to be the result of the data word being packaged with either the wrong label field, or the wrong data field. Evidence also indicated that the CPU module's data processing stages before and after the data packaging operated normally for the ADR data.

The ADIRU data-spike failure mode occurred due to a combination of some form of trigger event, either external or internal to the unit, with a marginal susceptibility to that type of event within the CPU module of a limited number of units. This combination caused the ADIRU to enter a state that intermittently disrupted the CPU's processes for managing the storage and retrieval of temporary data, and the unit's BITE was not sufficient to detect some aspects of the failure mode, particularly the transmission of data spikes on ADR parameters.

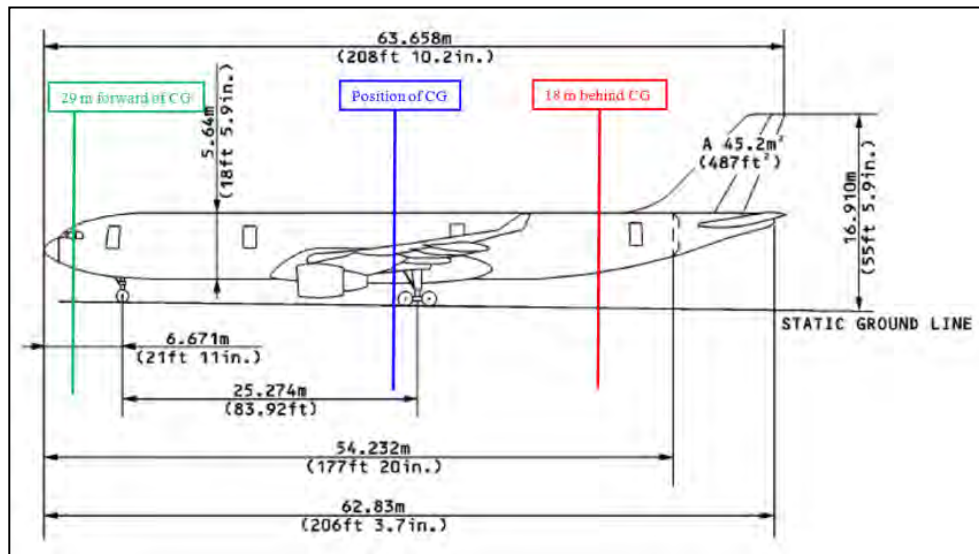
Figure A1: Reference positions for the vertical acceleration data

Figure A1 shows the position at which the FDR recorded vertical acceleration data (at about row 35). Based on the FDR data, the aircraft manufacturer also calculated the accelerations at a position 29 m forward of the c.g. (corresponding to the flight crew seats), and a position 18 m behind the c.g. (corresponding to about row 59).

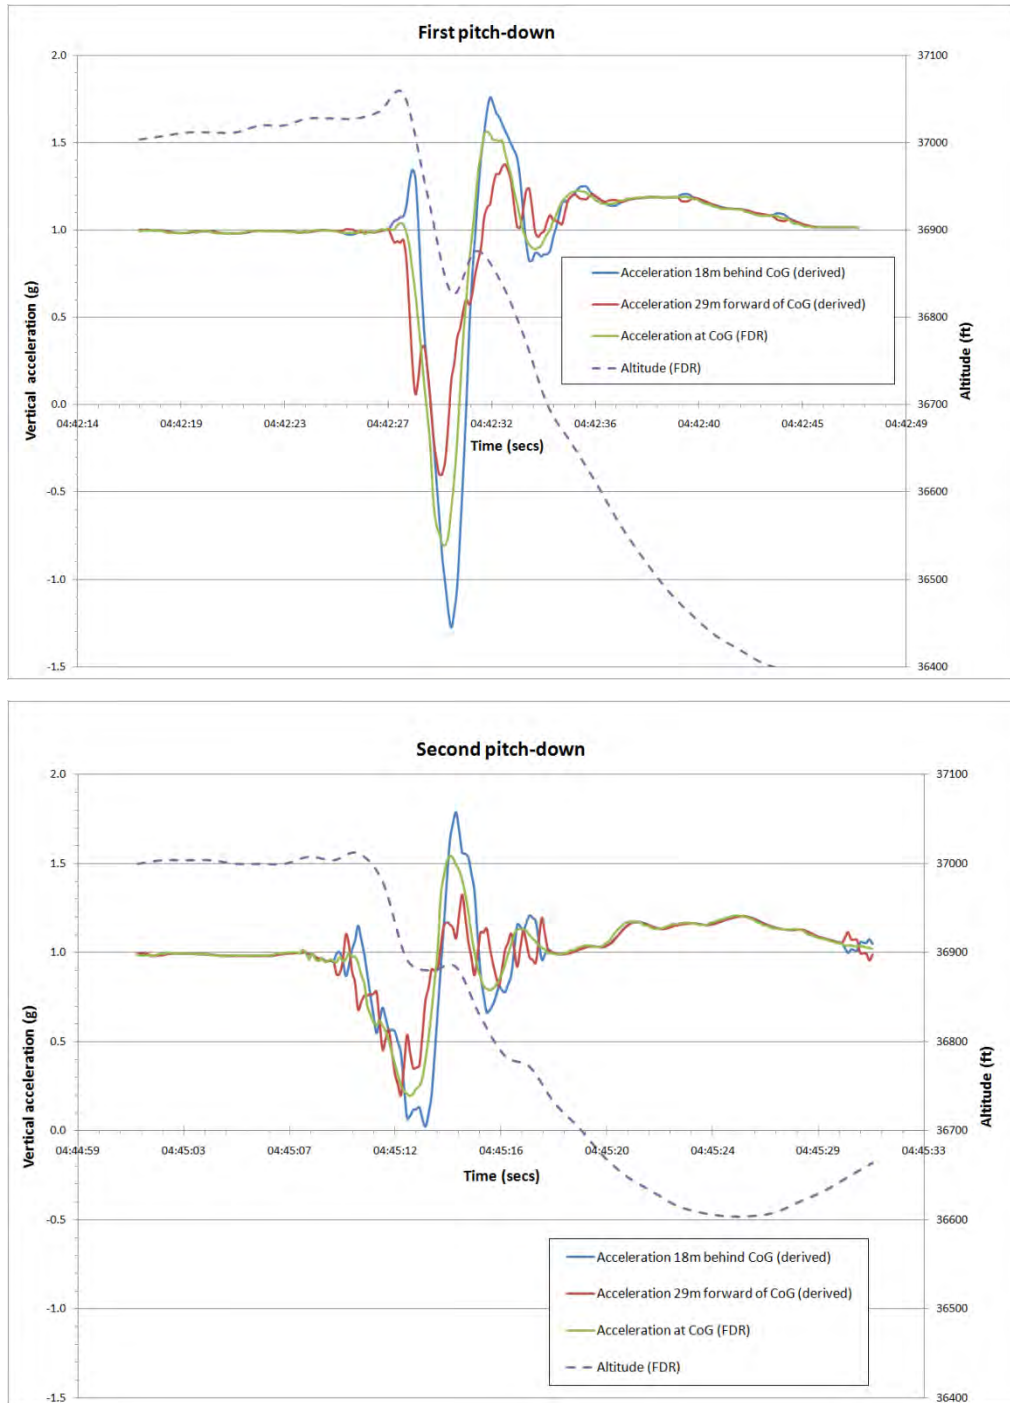
Figure A2: Vertical accelerations during the first (top) and second in-flight upsets (bottom)

Graphs of the accelerations for both upsets are provided in Figure A2. As shown in the figures, the accelerations were more significant during the first upset. The accelerations were also more significant at the rear of the aircraft than in the centre or front of the aircraft.

been important. The situation appeared to be more severe at the rear of the aircraft, where passengers who were unrestrained would have been initially accelerated upwards (as the nose came down and the tail went up) but the aircraft would have then started to descend. As a result, at the rear of the aircraft, there would have been relative motion between the aircraft and the passengers that could have combined to increase the force of impact with the aircraft cabin.

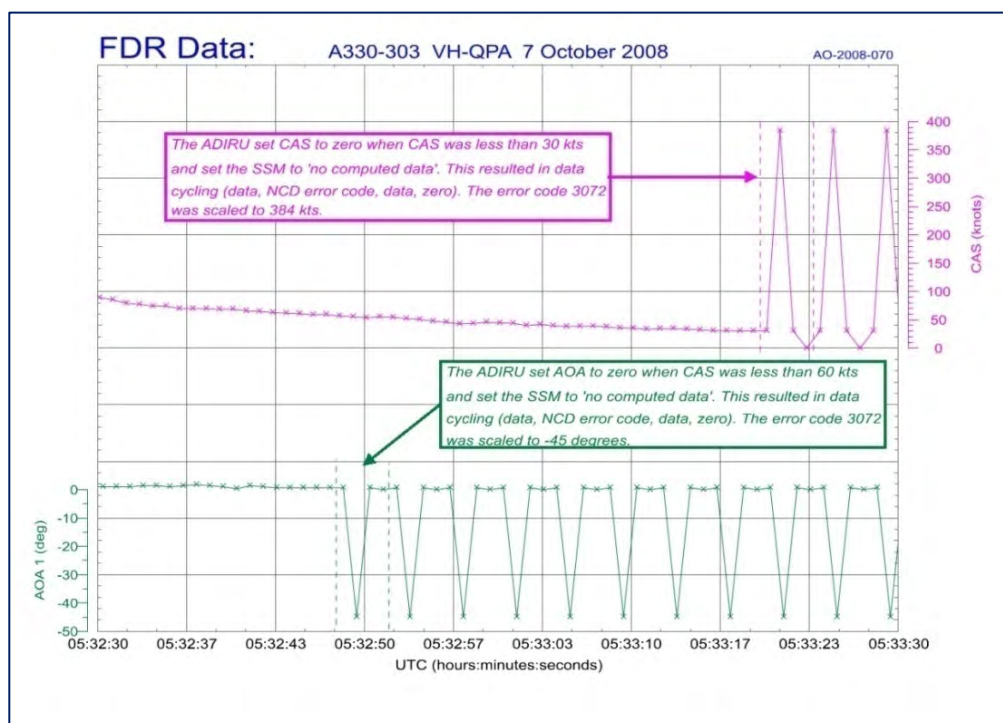
Figure B2: Parameter cycling due to FDIU error code

As noted during the 7 October 2008 flight, there were some corrected AOA values of -45° . These values were brief indications of no computed data rather than of data spikes with a -45° value.

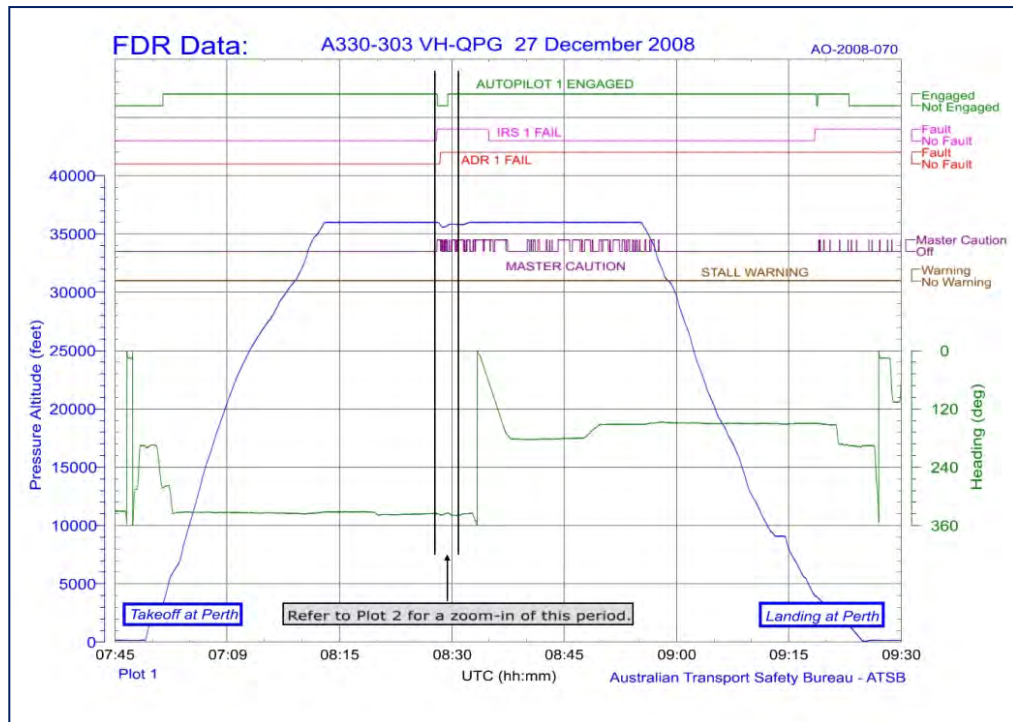
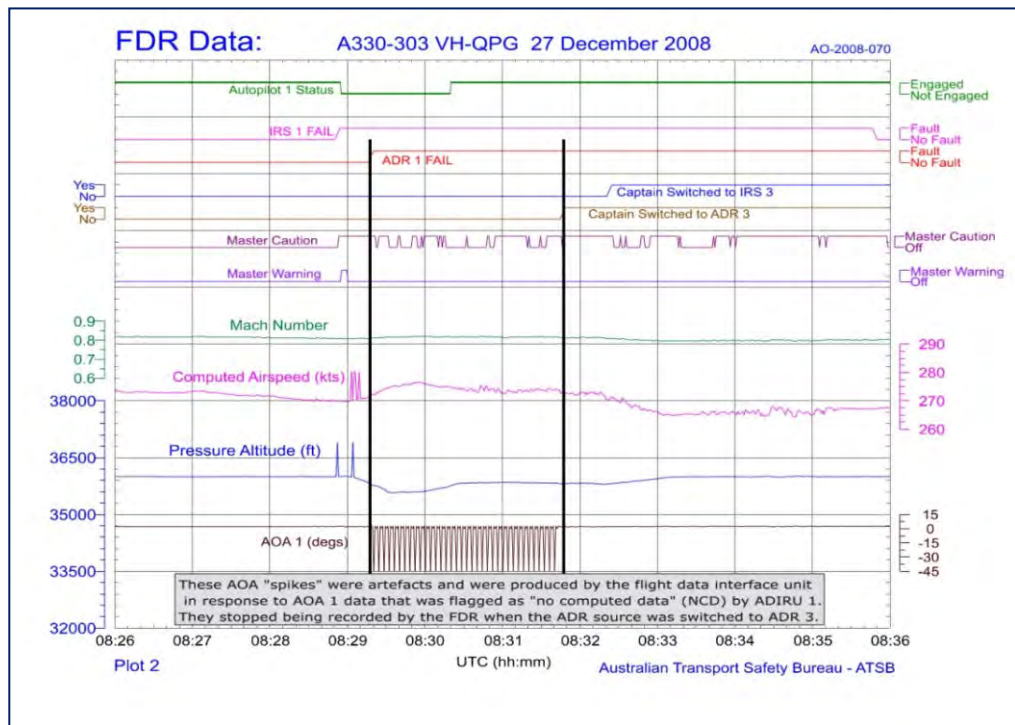
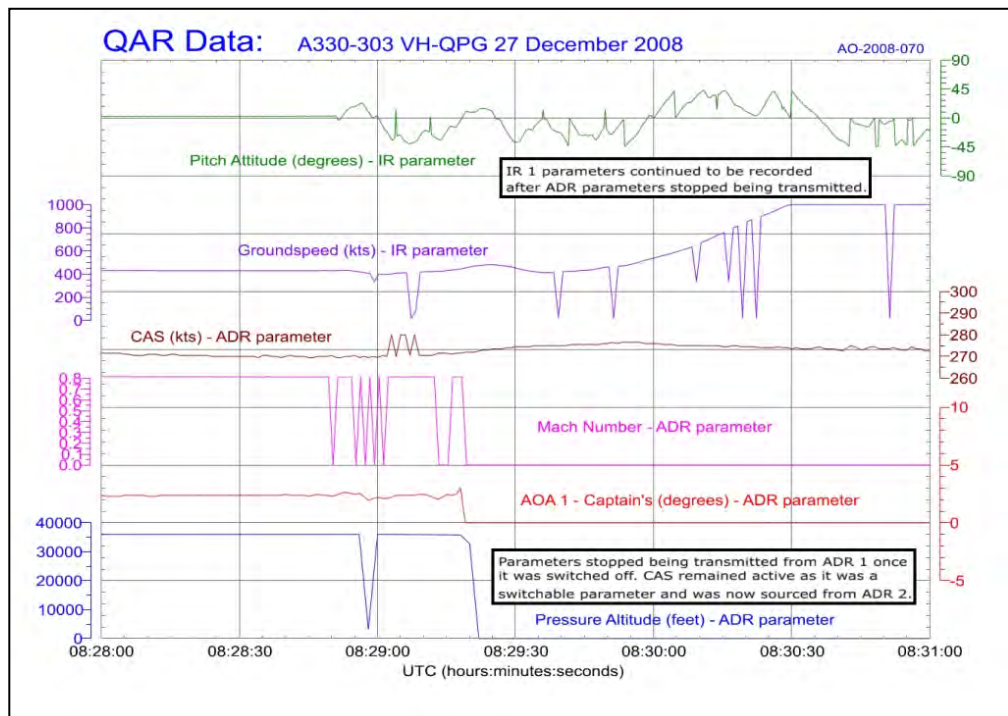
The recorded data showed that the failure mode started at 0828:52. In terms of the ADR data, the crew selected ADR 1 OFF 28 seconds after the failure mode started (at 0829:20). Consequently, ADR 1 ceased transmitting data and the FDR switched its source for the ADR parameters, except angle of attack (AOA) 1 and AOA 2, from ADR 1 to ADR 3.²⁰⁵ When the crew switched the source of ADR parameters for the captain's displays to ADR 3 (0831:25), the FDR's source of AOA 1 also switched to ADR 3. During the brief period that ADR 1 data was recorded:

- There were no spikes in AOA²⁰⁶ or Mach.
- There were two spikes for altitude, and two spikes for static air temperature. There were also four small changes (10 kts) in computed airspeed. ADIRU 1 flagged all of these anomalies as valid data.

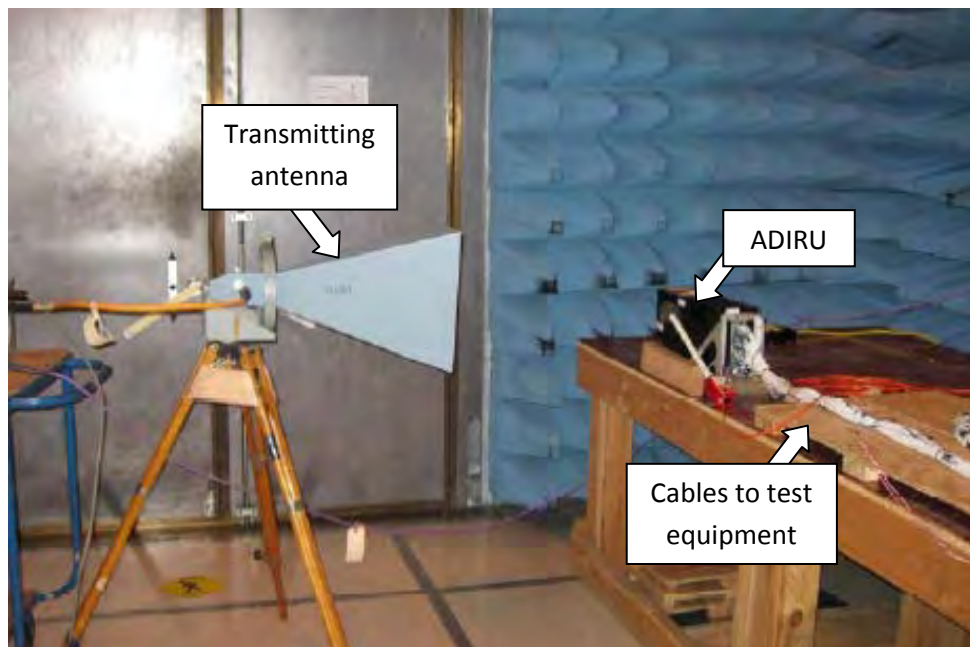
Figure E4: ADIRU undergoing EMI susceptibility testing

In terms of EMI, the range of frequencies tested incorporated the frequency ranges associated with all identified EMI-inducing sources, including other aircraft systems such as power supply and radio transmitters, the in-flight entertainment system, personal electronic devices (PEDs), and an Australian Defence Force communication station located near Learmonth (Harold E. Holt Naval Communication Station). The EMI testing incorporated additional slow sweeps and

dwells (sustained testing at a fixed frequency) at frequencies of interest, including: the transmission frequency range of the naval communication station, several internal clock and data frequencies used by the ADIRU, various aircraft radio transmission and reception frequencies, and 19 in-flight entertainment (IFE) system operating frequencies.

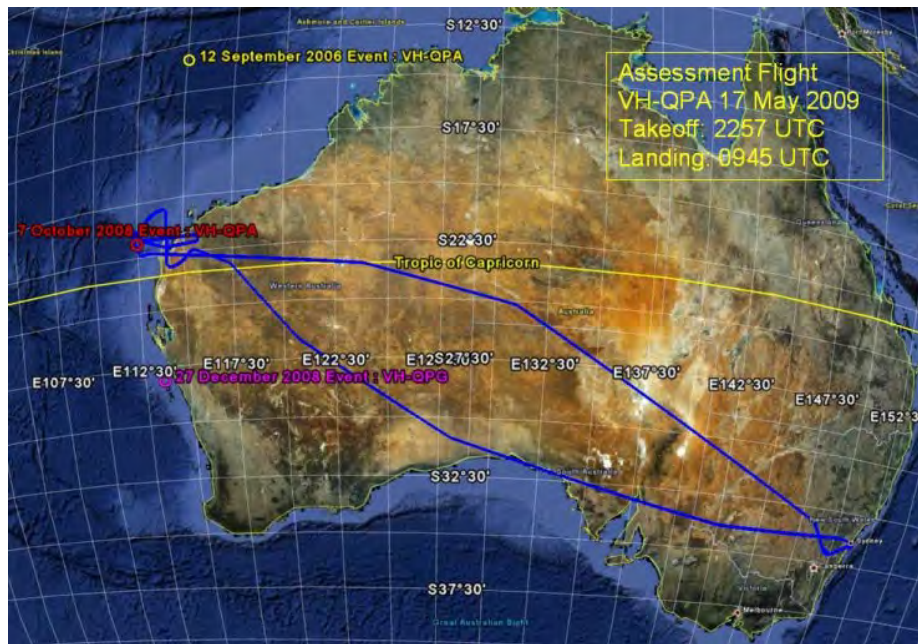
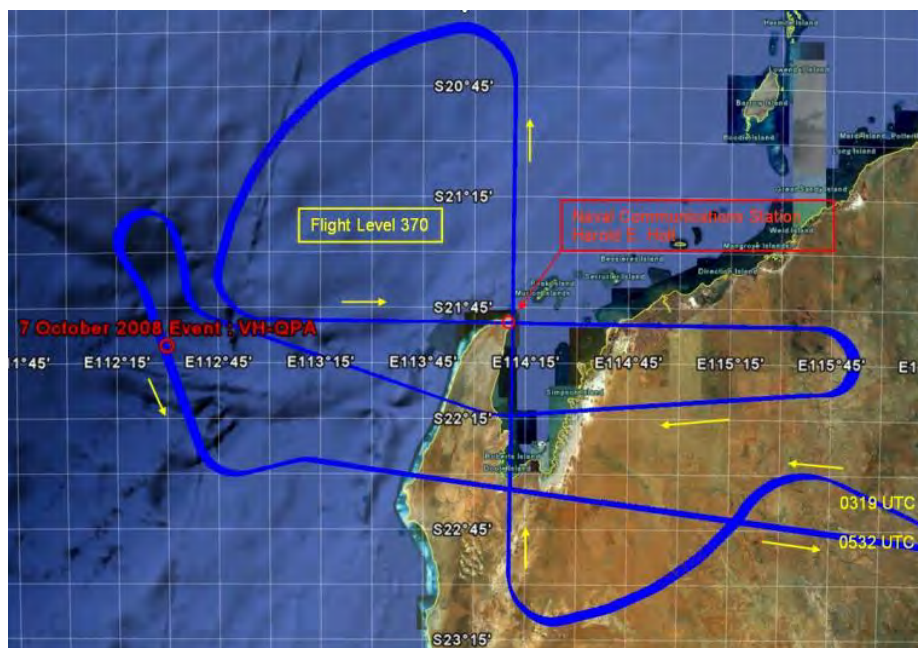
The naval communications station was later confirmed to be transmitting at the time of the assessment flight. No significant conducted current at the station's transmission frequency of 19.8 kHz was observed at any point throughout the flight (the level of coupling onto the ADIRU wiring was too small to be measurable).
