NATICK LABS Field Investigation Report

SUBJECT: Joint Land Attack Cruise Missile Defense Elevated Netted Sensor System (JLENS)
Failure Review Board (FRB) Report

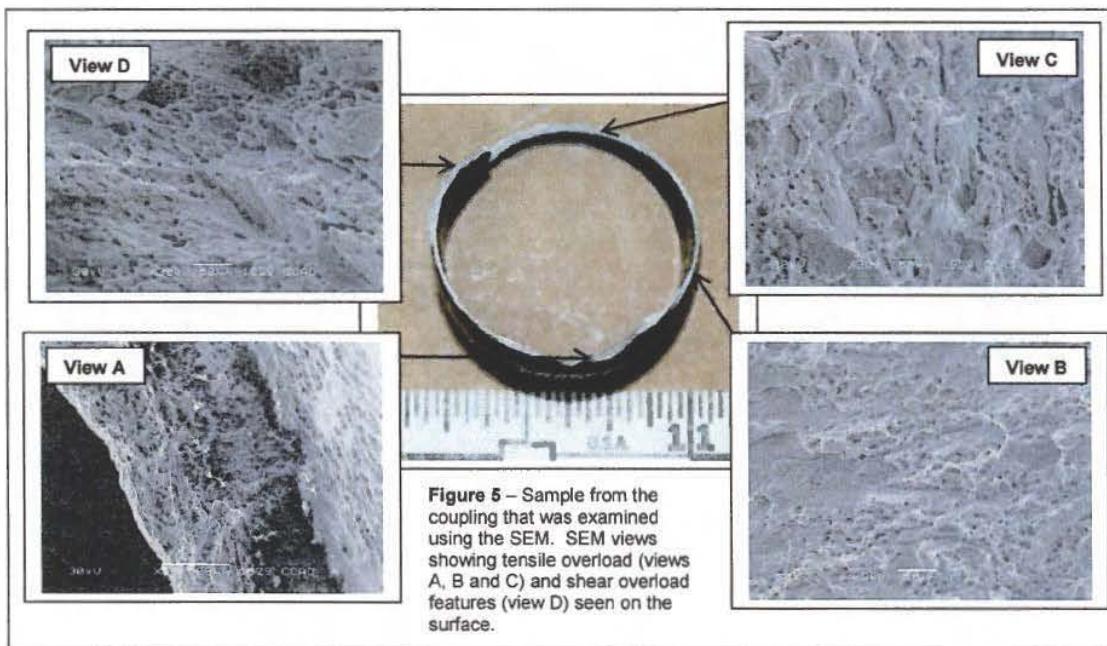
One of the fracture surfaces from the coupling was sectioned and prepared for examination using the Scanning Electron Microscope (SEM). The fracture appeared to have originated in the area adjacent to the spring plunger. The fracture progressed around and through the coupling. SEM examination revealed areas of cup cone topography around the majority of the fracture surface. Where the coupling finally broke, areas of shear overload were present (Figure 5). No other anomalies were noted on the fracture surface which might have contributed to the fracture.
