Road Hunt:

A Survey of Road Closure Effectiveness In the Flathead National Forest's Swan Valley Geographic Area

by
Keith Hammer

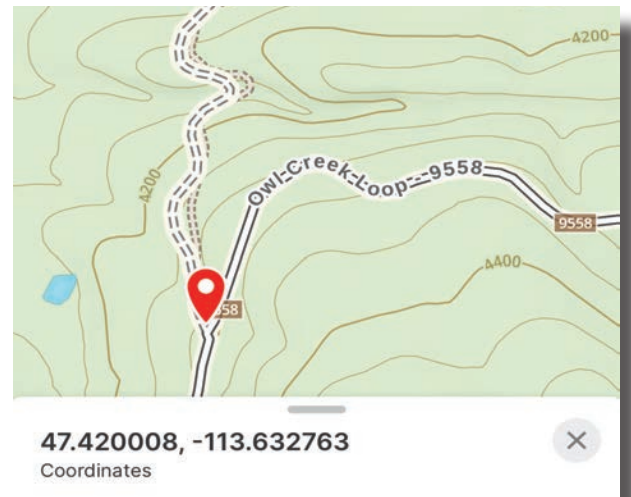
Fig. 6

For example, Figure 6 is a GAIA GPS screenshot of the location of the road closure shown in the Solocator photo in Figure 1. Clicking on the dotted-line/closed road would reveal its number (10561) and the meta-data concerning its closure and maintenance status.
