## National Safety Committee

### Dynamic Testing of Yacht Stanchions

Conducted during August 2013

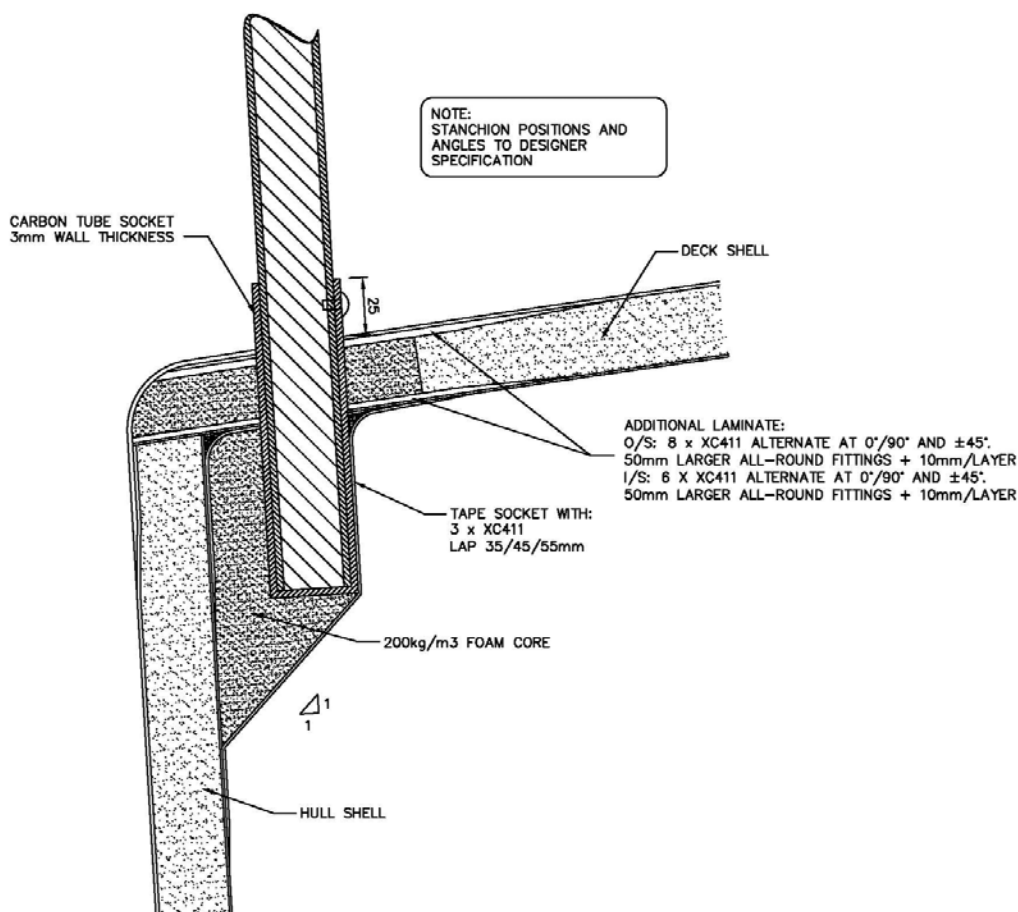
Such a design is shown below – Fig. 21:

The simulated deck edge socket, made from pine wood (Fig. 17), remained intact in all instances after suffering 6 successive impacts. It was constructed so as to simulate the design strength of a composite hull/deck join incorporating stanchion socket, commonly found today.

It is important to note that the deck-edge and stanchion mounting design must have strength exceeding the bending strength of the stanchion. This is easily achieved but a hierarchy of failure should have the stanchion failing before

the deck-edge and socket. An alternative way to achieve the same result is to incorporate a spigot that fails before the deck-edge and socket can be compromised.
