Imperial College London

Building Bridges 2015

An engineering expedition to Malawi, central Africa

Uledi Bridge – Inspection and Maintenance Summary

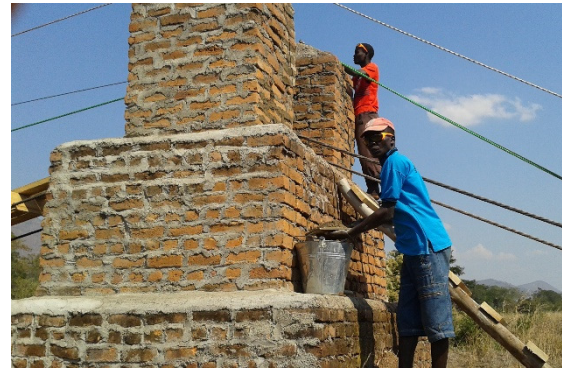
Figure 8: Skilled builders re-pointing the towers

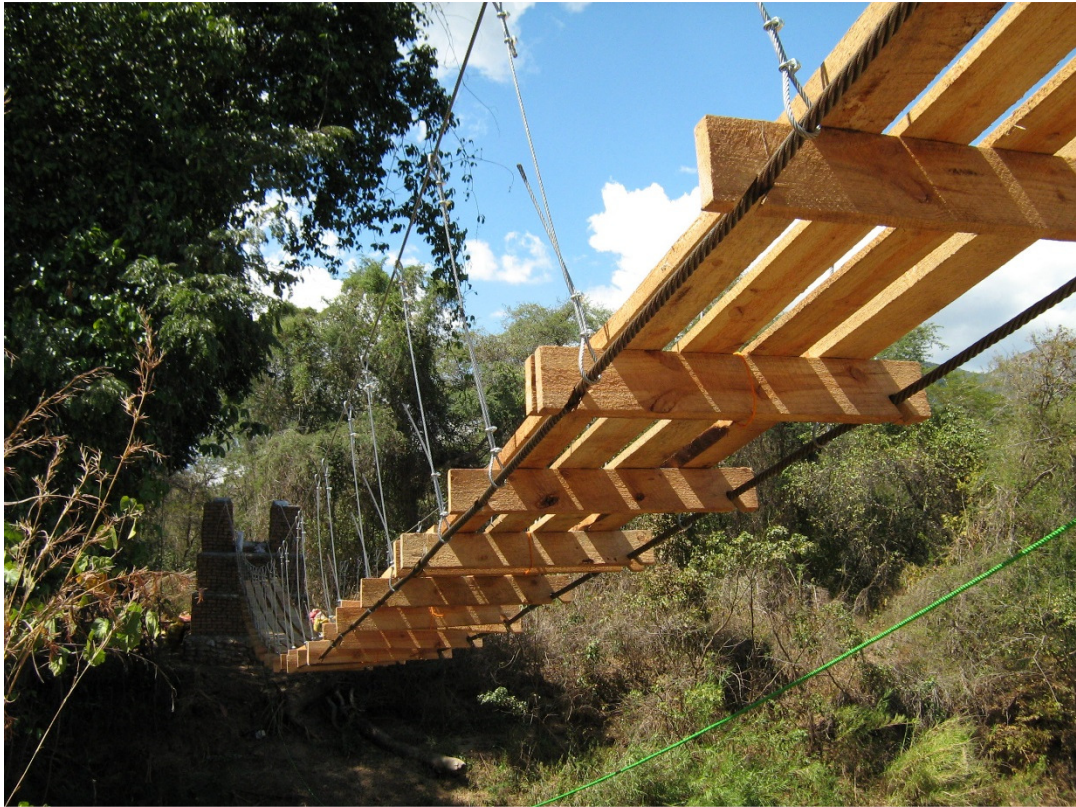
The bridge as-built in 2007 – view from left bank

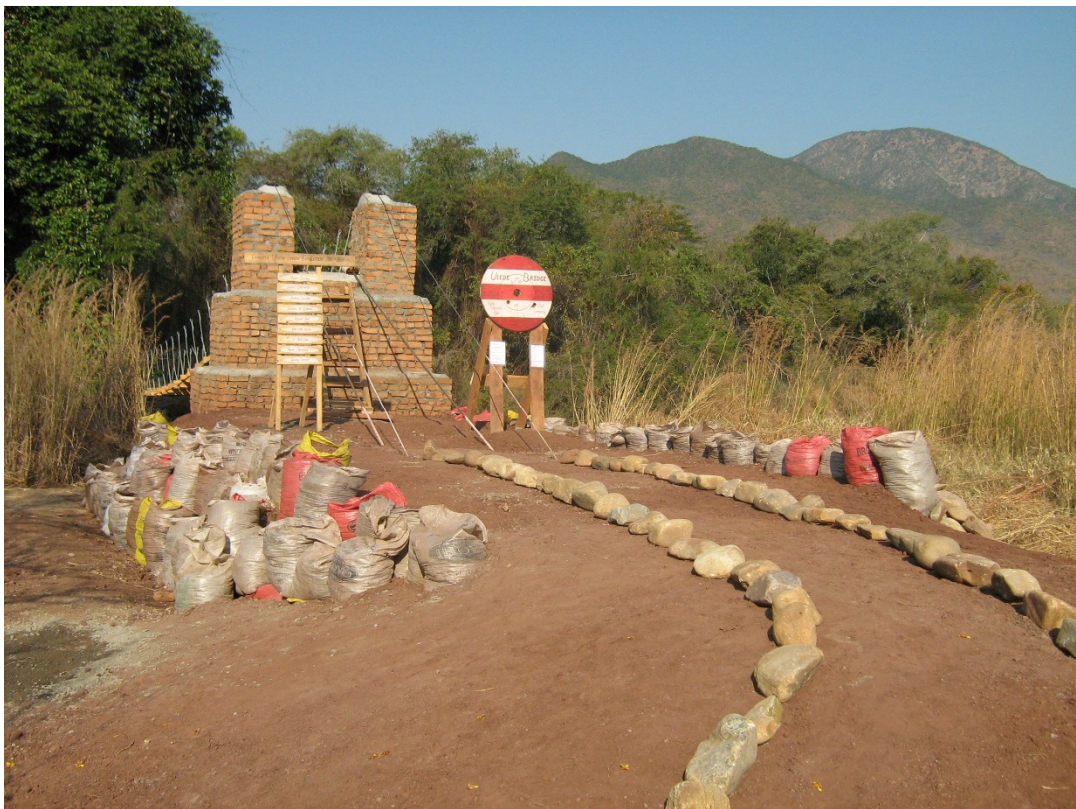
Tower and embankment in 2007

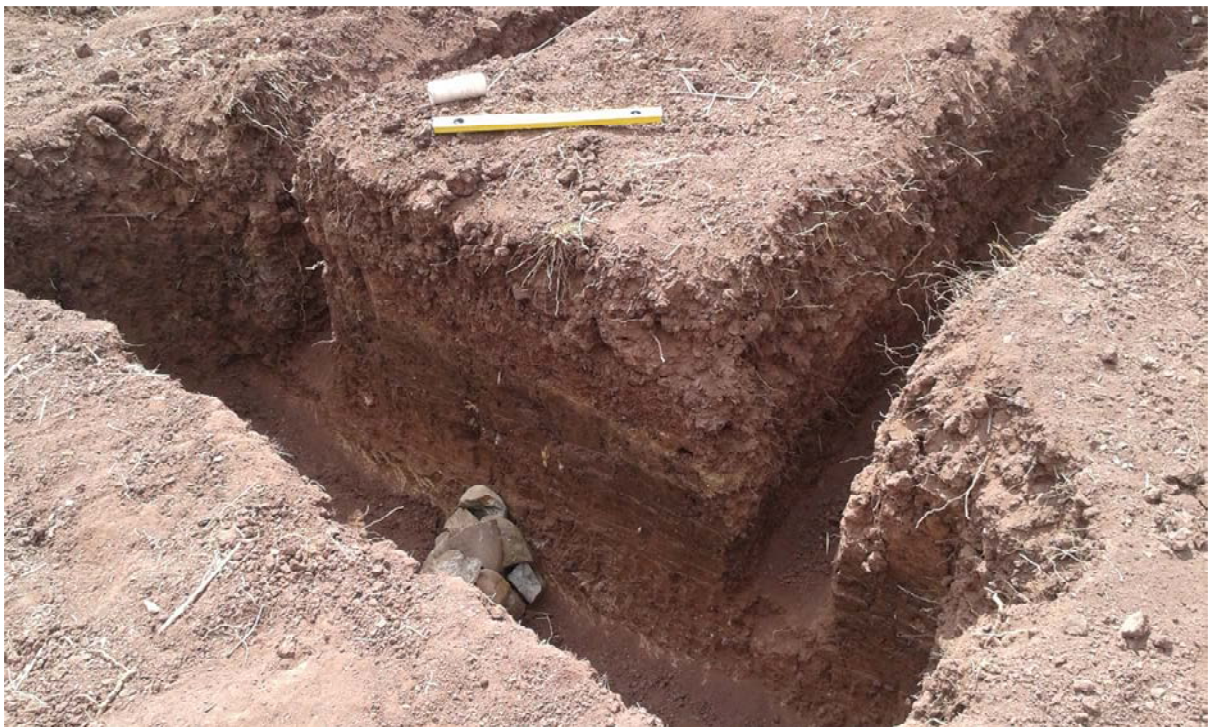
Handrail anchor before concreting

Anchors were constructed to take the load from the new handrails. These were placed below ground level and behind the original anchors built in 2006 and 2007 on both banks. There are two handrail anchors on each bank, measuring 1.2m wide by 0.4m deep by 0.8m long (as shown in the schematic below). On each bank a single excavation was made to 1m below ground level. The handrails were designed to be placed in their original positions and to run over the tower saddles, with a separation distance of 1.6m. The space between the two anchors was infilled with rocks that had been broken to have jagged edges and which were placed interlocking each other.

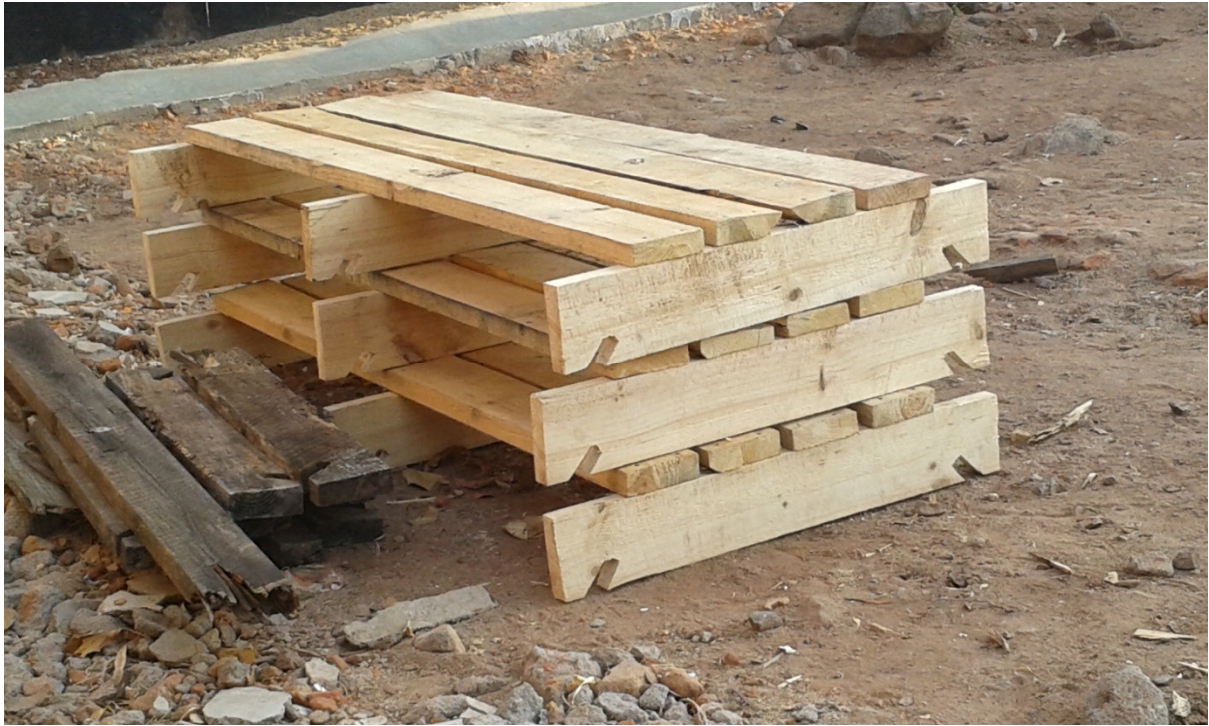
Replacement decking units

New decking units were constructed from soft wood provided from Chelinda plantation by the National Park. The units were of the same dimensions and design as the 2006 and 2007 units and were built by local carpenters. All units were replaced. Replacing the decking units had a very positive effect on the bridge stiffness.

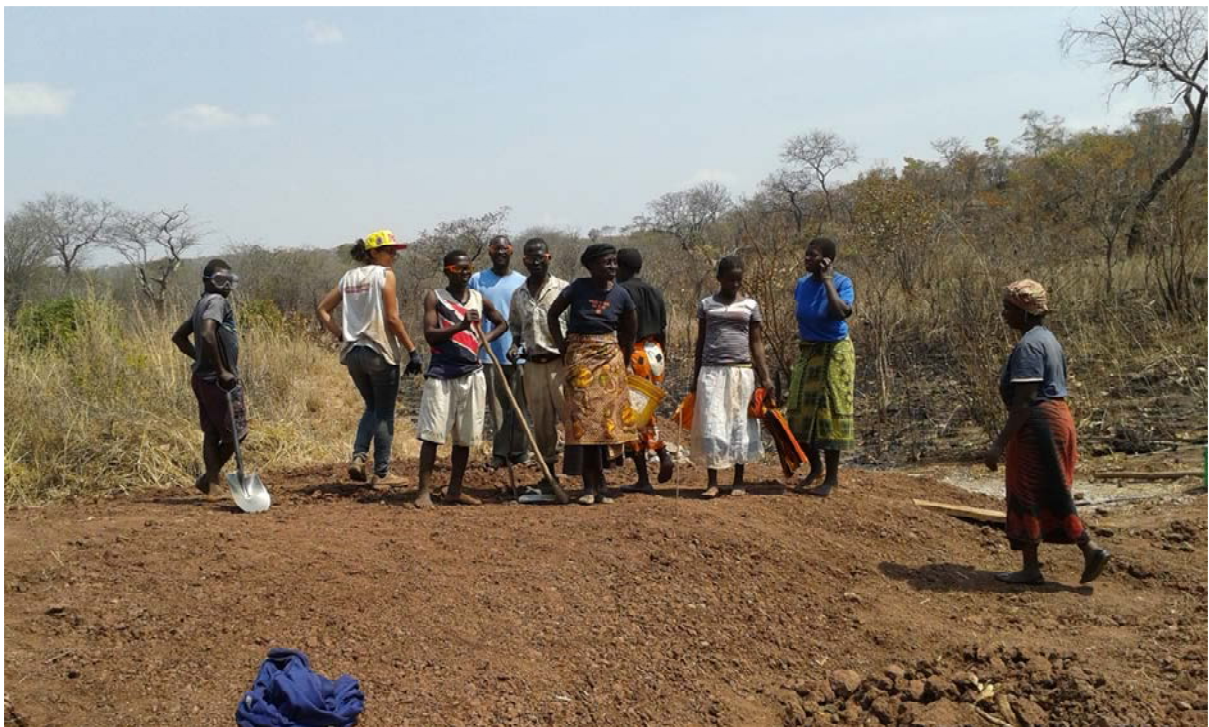
Compacting embankment to 0.5 m above ground level

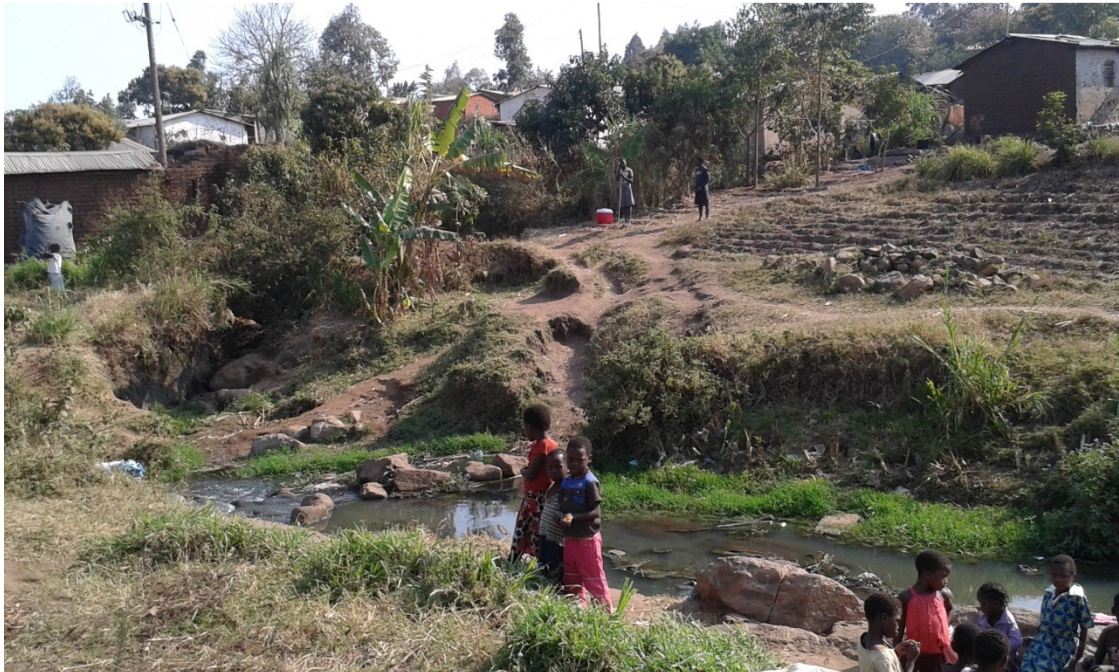
Geology appears to comprise limestone bedrock which outcrops within the river bed. The river banks are typically 1 -2 m high and comprise weathered limestone and residual soil, and river deposits of sandy clay. At places on the banks sizeable limestone boulders were observed, up to 3 m in diameter; these do not appear to be recently deposited. Boulders and shallow bedrock may cause problems for excavation during bridge construction.

The most appropriate bridge location identified during the walkover is shown in Figure 4. This is located on a reasonably straight stretch of river with less significant erosion than other locations. However, to maximise the bridge lifespan the towers would need to be located as far from the river as possible. A minimum span was measured as 19 m.

Figure 4: Preferred bridge site, downstream of existing crossing point

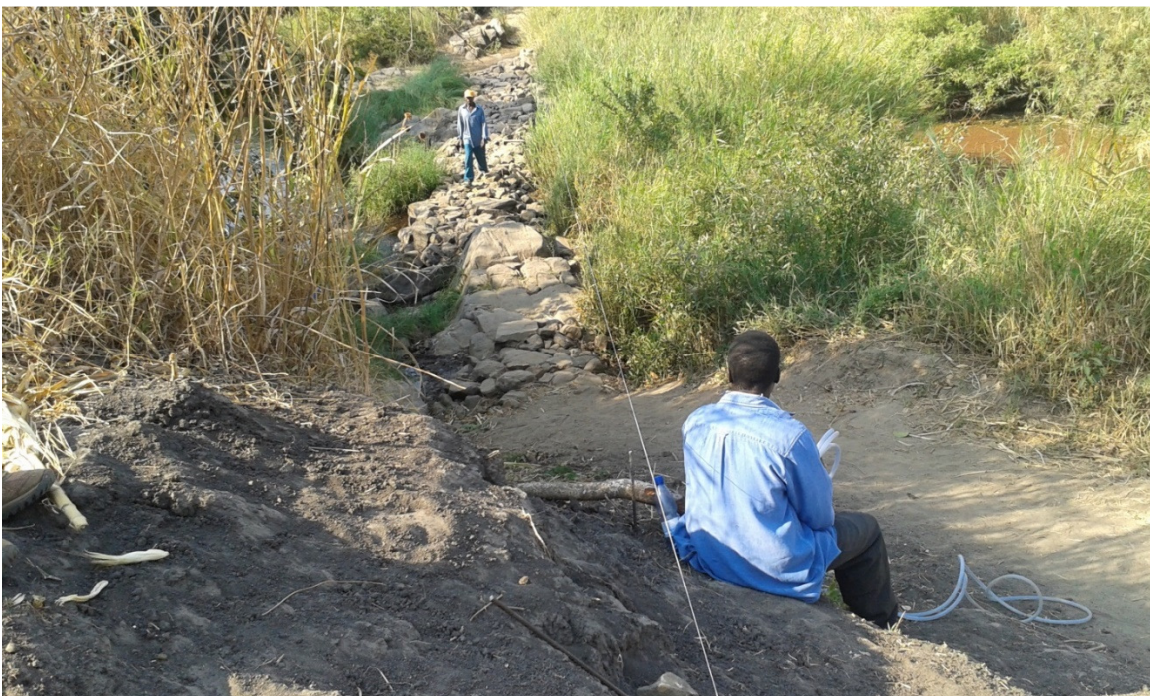
The existing crossing, shown in figure 4 is at a bend in the River Linthipe, where the channel is relatively wide and shallow. Established footpaths approach it from both sides and connect the communities and the main road. The community had built an elevated stone footpath, which allowed users to cross on foot during the dry season when the water level was low without getting their feet wet. However, by creating a geometric blockage, during the rainy season this will increase the water level. The river upstream of this crossing was stagnant as a consequence of the blockage. The local community was advised this provided conditions for mosquito breeding and increased their risk of malaria and to introduce drainage channels in the footpath.

Figure 4: Existing crossing showing line of level survey over raised footpath

The team carried out a simple level survey using a hose pipe filled with water and a tape measure. The results are in the table below. This method is useful for in the field measurements with very simple equipment and is very approximate. A more detailed survey using more accurate methods is recommended prior to any construction. The survey took place on a line between the proposed
